Manhole Inspection Summary

Manhole # S06II2022MH

Insp Date: **7/15/06 8:11 AM**

Location Address: **3506 SHELBURNE RD**

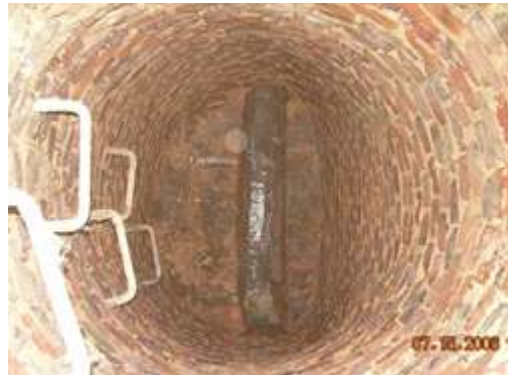
Top View

Corbel infiltration. Evidence of surcharge - Bench debris. Corroded steps.

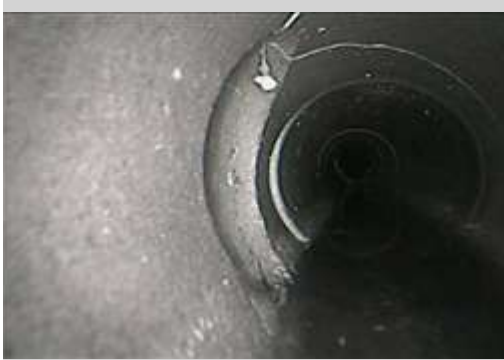
Inside of the I6

Comments **The I6 pipe picture shows Channel debris and grease deposits.**

Circumferential cracks.

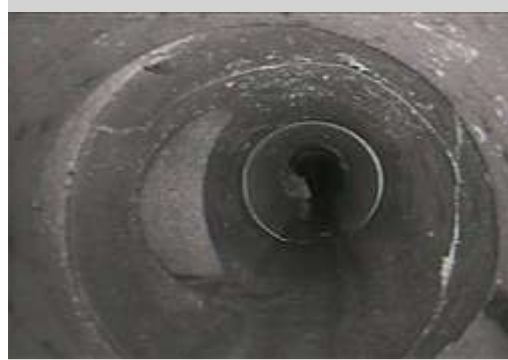
Inside of the O12

Circumferential cracks.

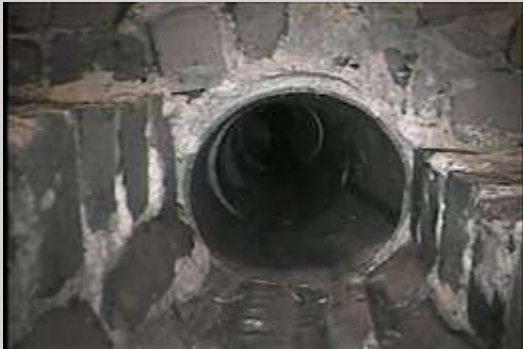
8 in. Circular Gravity Sewer Pipe Out @ 12 O'Clock

Invert Depth: **10.06** (ft.) Flow Characteristics: **Slow**

Infiltration: **Evidence** Pipe Seal Cond: **Unknown**

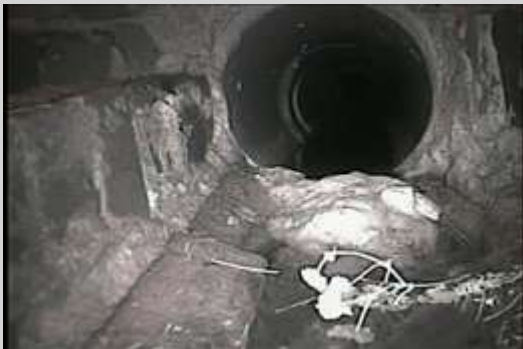
8 in. Circular Gravity Sewer Pipe In @ 6 O'Clock

Deposits: ☐ None ☐ Mud ☐ Sludge ☒ Debris ☒ Grease

Silt Depth: **0** (in.) Deposits Extent: **Light**

Infiltration: **Evidence** Pipe Seal Cond: **Unknown**
